SCS DAM PA-445

NDI NO. PA-00099

PHASE I INSPECTION REPORT.
NATIONAL DAM INSPECTION PROGRAM.

MAR 1980

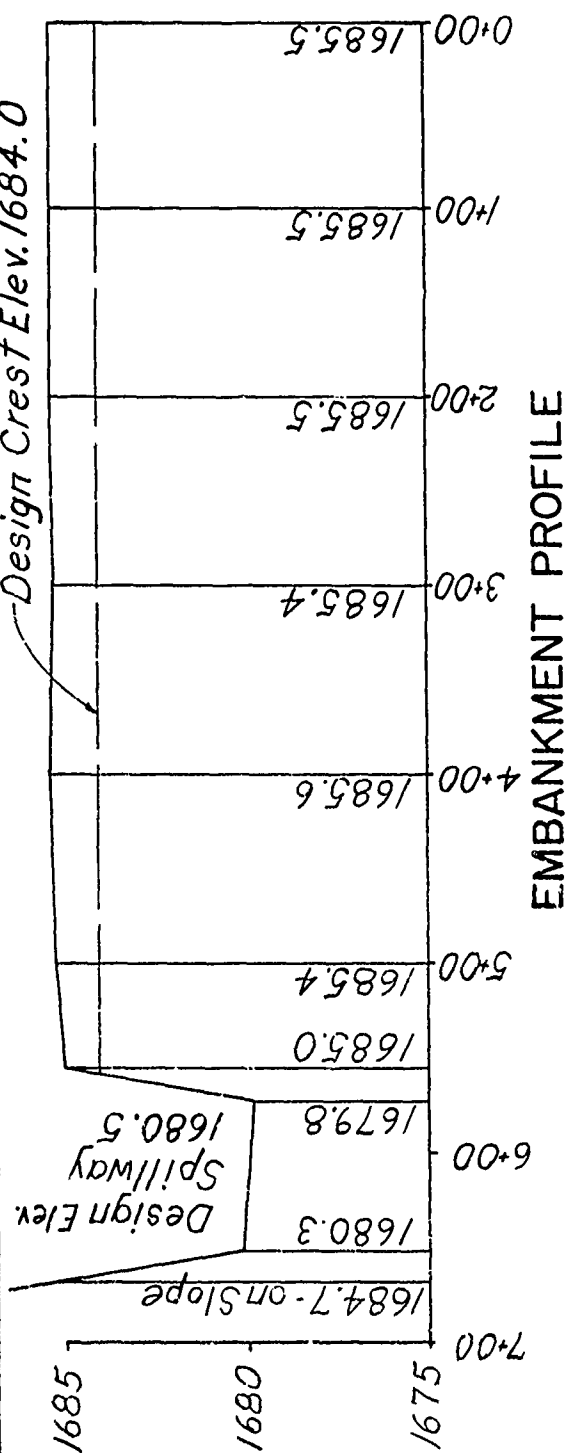
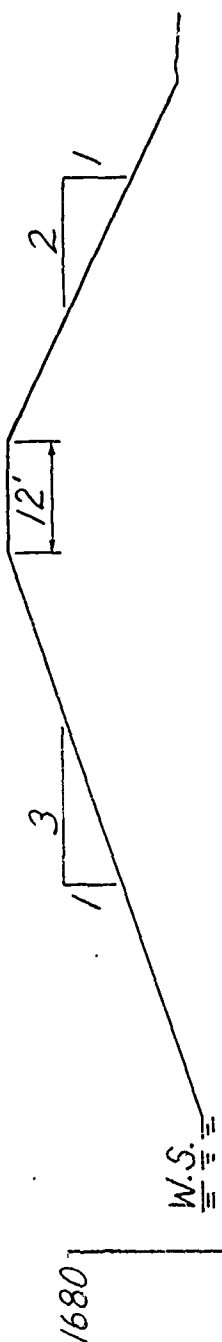
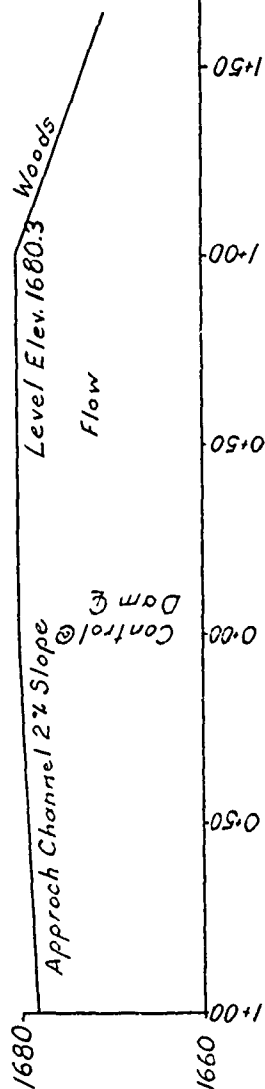
INSPECTION SURVEY
PLATE A-I

The emergency spillway in the left abutment appeared to be in good condition with a good grass mat for erosion protection. The side slopes are stable and the flow of water is directed away from the toe of the dam by a spur dike. (Appendix A, Plate A-I). The principal spillway appeared to be in good condition.
